# Single rehabilitation on Shelta implant using a XA abutment

Laguna Martos M.

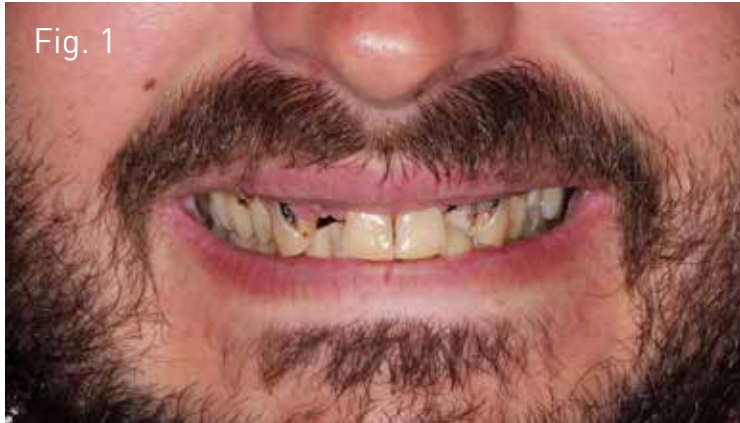
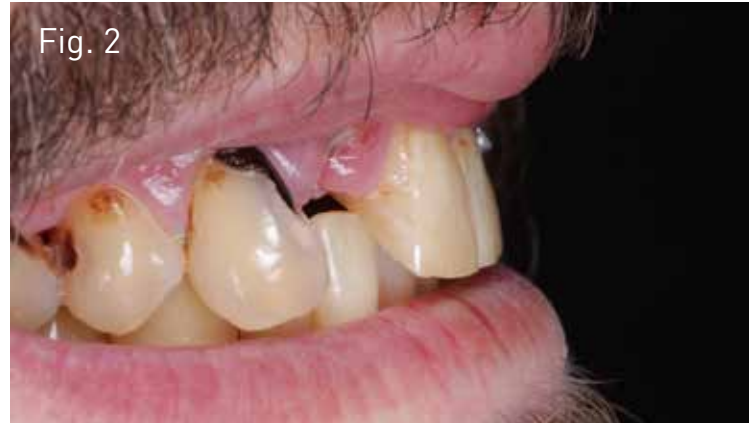
Fig. 1

Pre-op clinical images: the general situation is unfavourable, several caries lesions can be noticed and the element 1.2 is clearly hopeless

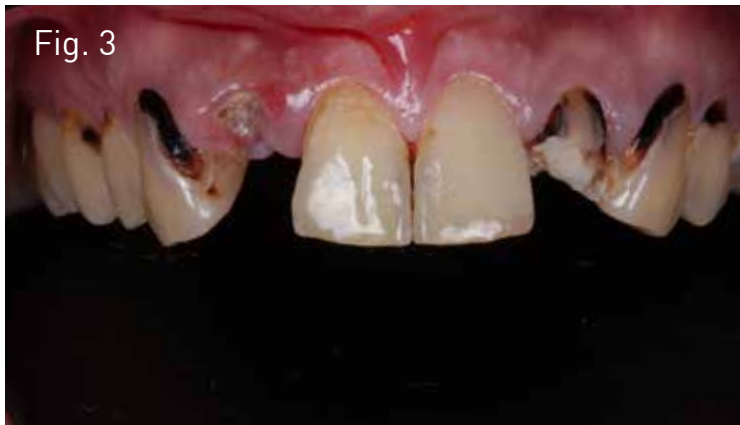
Fig. 3

Detail of the pre-op situation

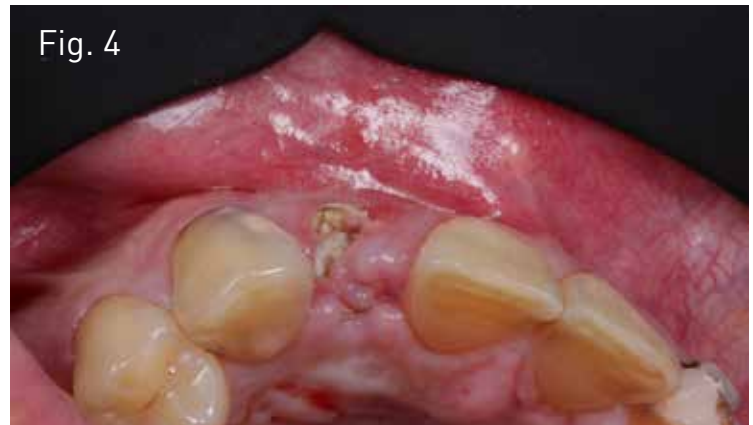
Fig. 4

Occlusal view of element 1.2

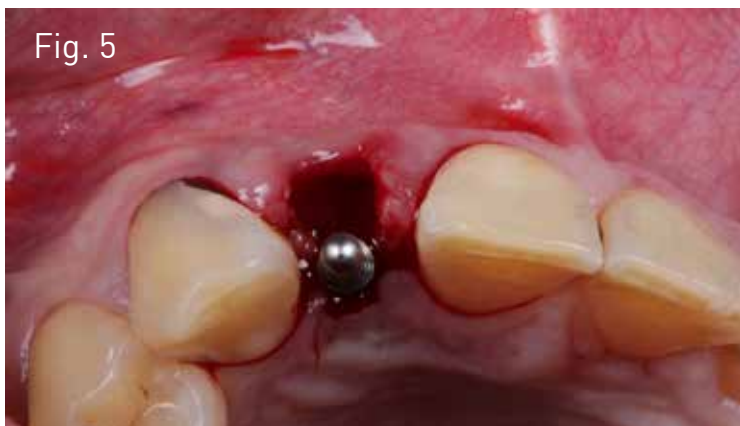
Fig. 5

The implant site is prepared, and a parallelism post is used to check the correct insertion axis

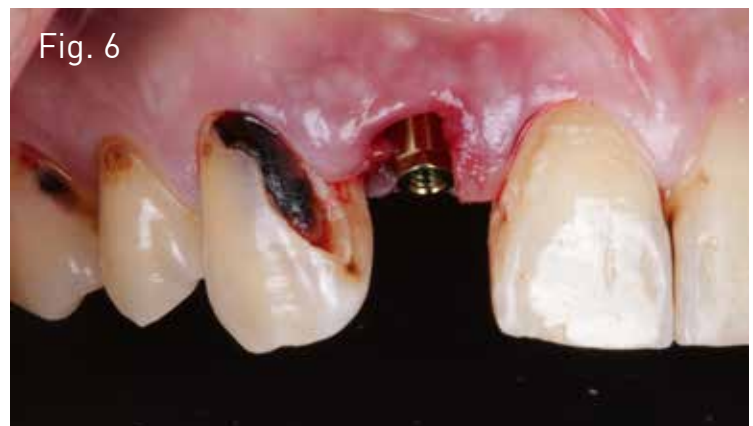
Fig. 6

A Shelta tapered implant is placed, and a XA abutment for screw-retained prosthesis is connected to the implant

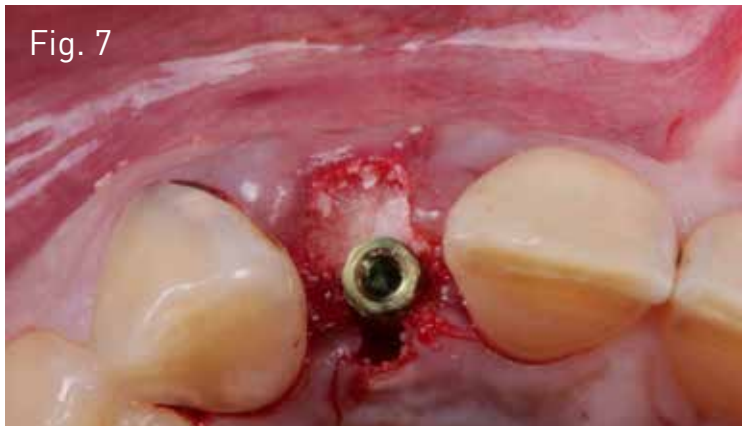
Fig. 7  
Occlusal view of XA abutment: the gap is grafted with some biomaterial

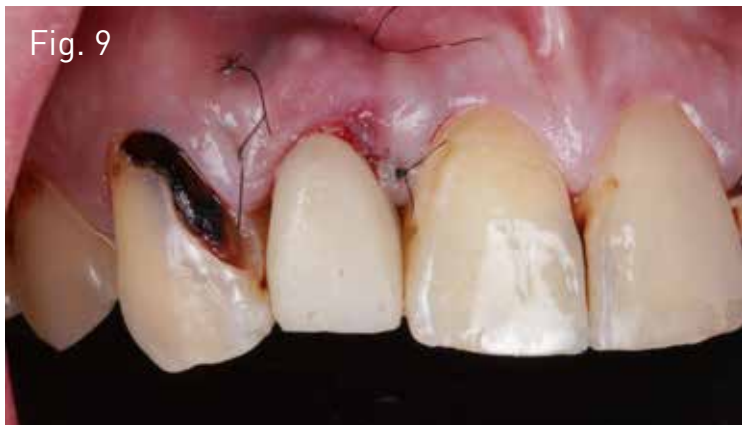
Fig. 9  
The temporary crown is placed

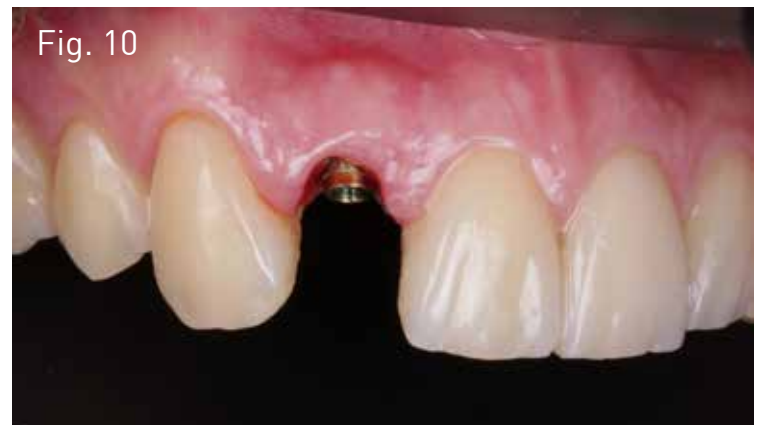
Fig. 10  
At the same time, a restorative therapy on the decayed elements is performed, with the application of direct veneers in composite

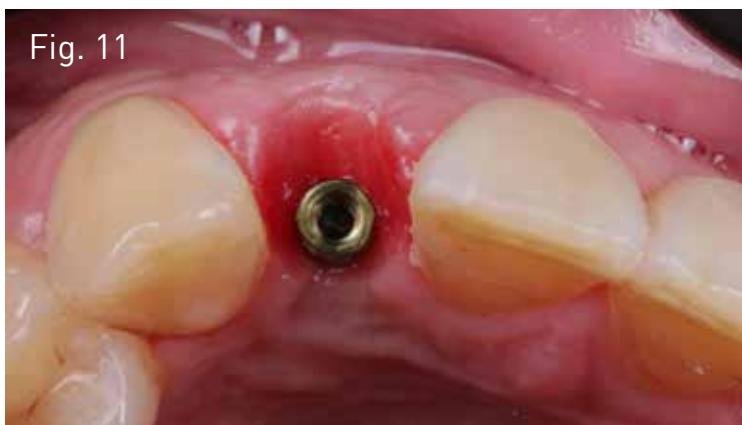
Fig. 11  
By removing the temporary crown, the correct development of the emergence profile around the rehabilitation can be noticed

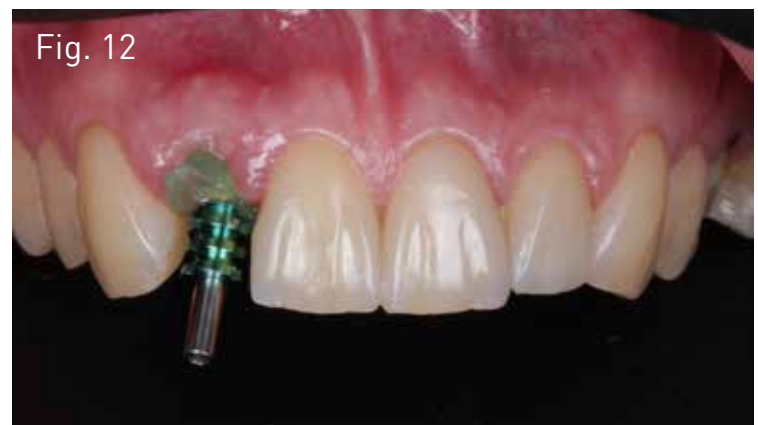
Fig. 12  
Impression is taken using the dedicated Pick-up transfer directly on the XA abutment, following the principles of One Abutment - One Time technique

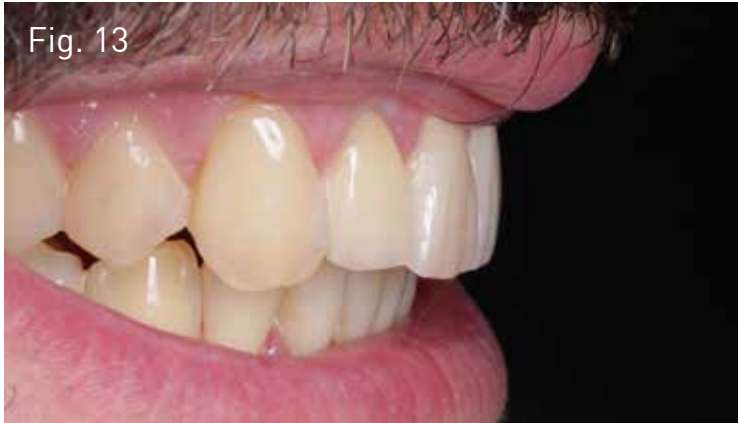
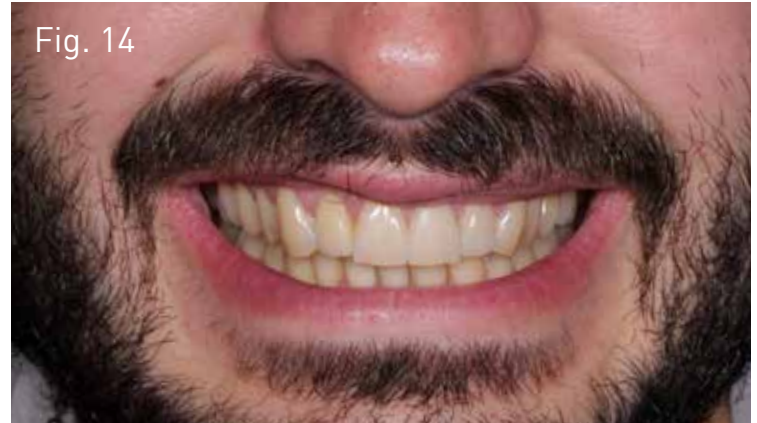
Final clinical images: the rehabilitation on Shelta implant and XA abutment is completed with success, the final result is absolutely good-looking

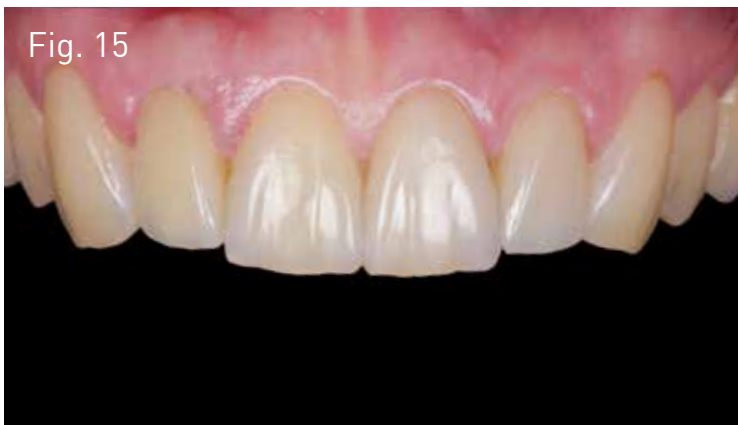
Detail of the post-op situation

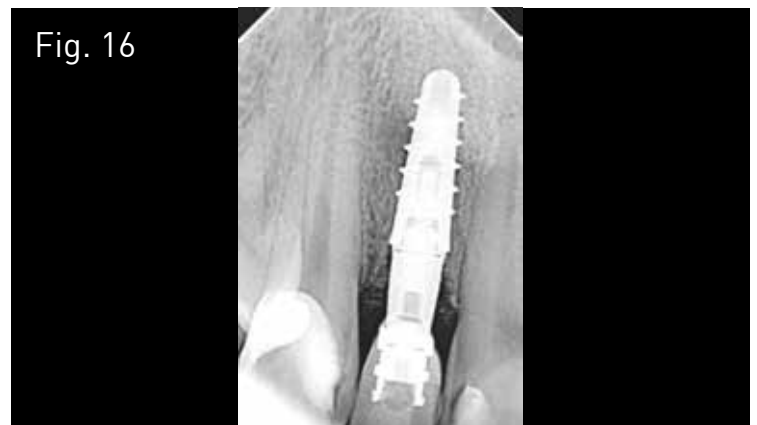
Nine months RX follow-up
